CENTRAL EAST STABILITY LIMIT ANALYSIS FOR ALL LINES IN SERVICE AND OUTAGE CONDITIONS (CE-23) APPENDICES

A Report by the
New York Independent System Operator

September 2023

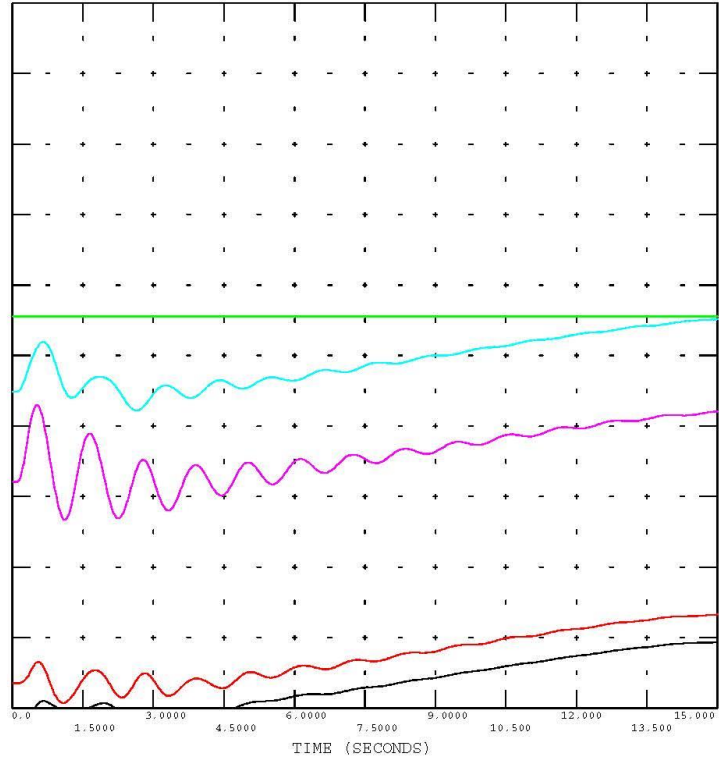
2023 CE STAB, 22DYNPK, CASE C3F036, 008351 0%SCMB
 180S, CE 2834, DYSE 3466, MG 3082 ONNY 3767

CE23SRGAB_PH3_STABILITY

FILE: F03 CE99.out

CHNL# 129: [ANGL 147757 [AFLT124.000] [1]
 CHNL# 126: [ANGL 147753 [N126_4 13.800] [4]
 CHNL# 124: [ANGL 147768 [MOS25-2613.800] [3]
 CHNL# 118: [ANGL 147777 [G11808#117.000] [1]
 CHNL# 102: [ANGL 136700 [SM FT 2025.000] [2]
 CHNL# 63: [ANGL 125190 [ROSE G1124.000] [1]

TUE, SEP 05 2023 10:34
 ANGLE RESPONSES

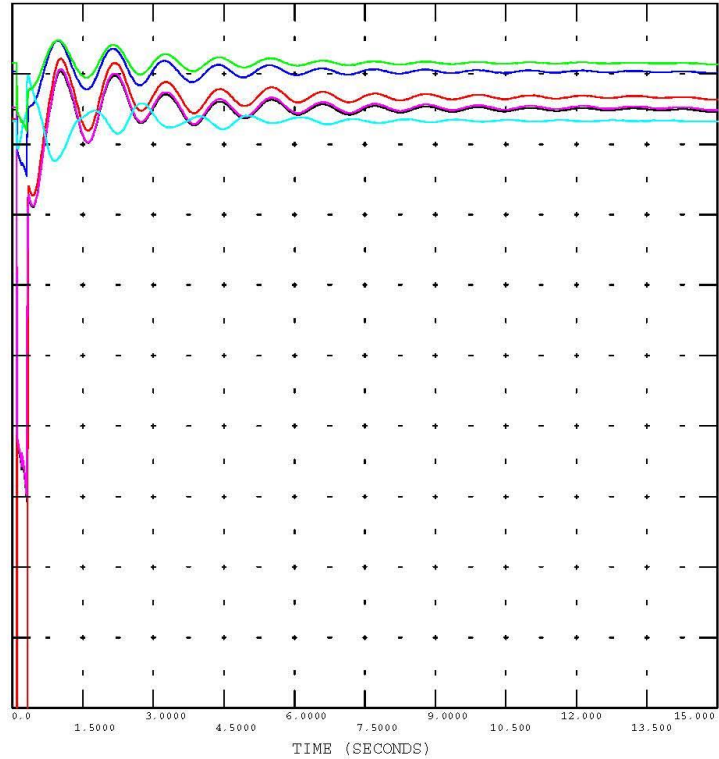
2023 CE STAB, 22DYNPK, CASE C3F036, 008351 0%SCMB
 180S, CE 2834, DYSE 3466, MG 3082 ONNY 3767

CE23SRGAB_PH3_STABILITY

FILE: F03 CE99.out

CHNL# 457: [VOLT 125001 [ROCKTIV 345.001]
 CHNL# 441: [VOLT 147824 [N126 345345.001]
 CHNL# 429: [VOLT 147833 [NARCXY 71345.001]
 CHNL# 437: [VOLT 147830 [JA FLT2345.001]
 CHNL# 432: [VOLT 137451 [LBDS 3 345.001]
 CHNL# 429: [VOLT 137200 [BDIC 345.001]

TUE, SEP 05 2023 10:34
 VOLTAGE RESPONSES
